# **Confidential Inspection Report**

**Palm Bay, FL**

**September 14, 2014**

**Inspector: Ronald Burns HI939**

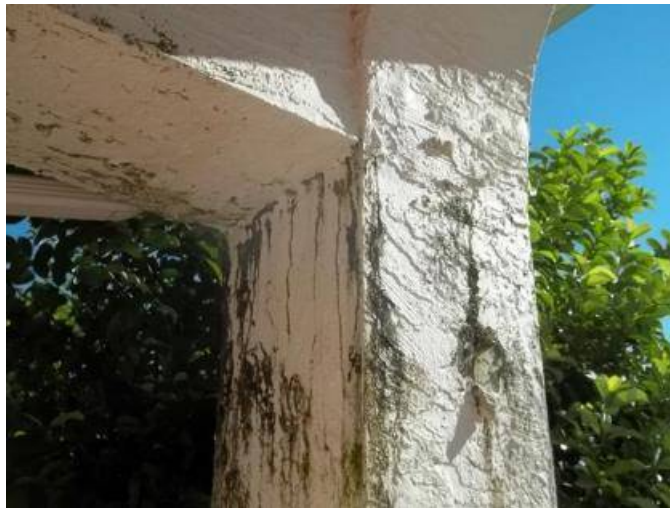
Water is entering the building envelope through the exterior wall on the north of the front entry due to improper flashing at roof to wall junctions. When the exterior finishes are removed all subsequent damage will be visible. It is necessary to remove the water damaged exterior finishes to determine the extent of repairs that are needed to the structure on north side of the front entry.

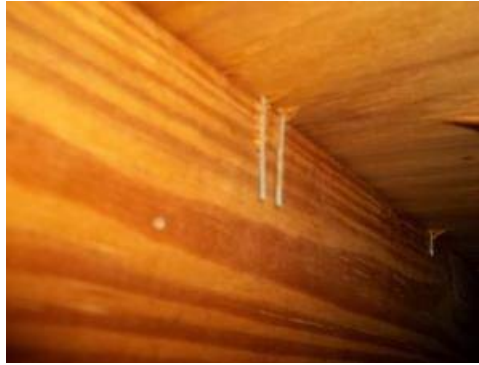
Evidence that the roof sheathing is fastened to trusses with small gauge staples. Roof sheathing should be properly fastened to the wood truss top chords with appropriately sized nails. This requires removal and replacement of the roof covering.

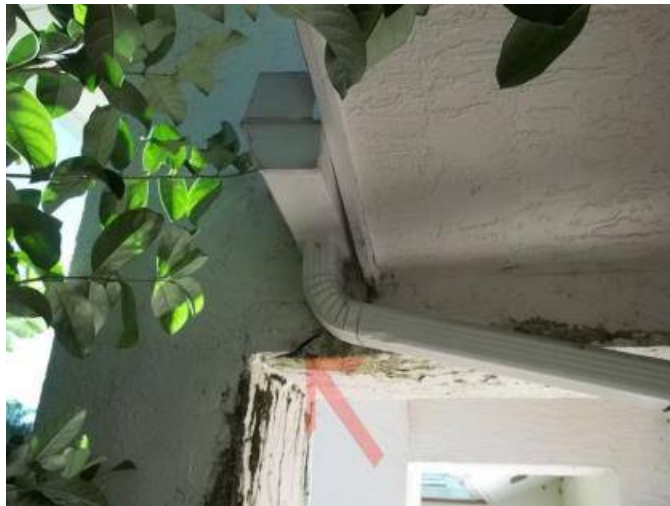
Water has been entering the column shaft on the north side of the front entry.

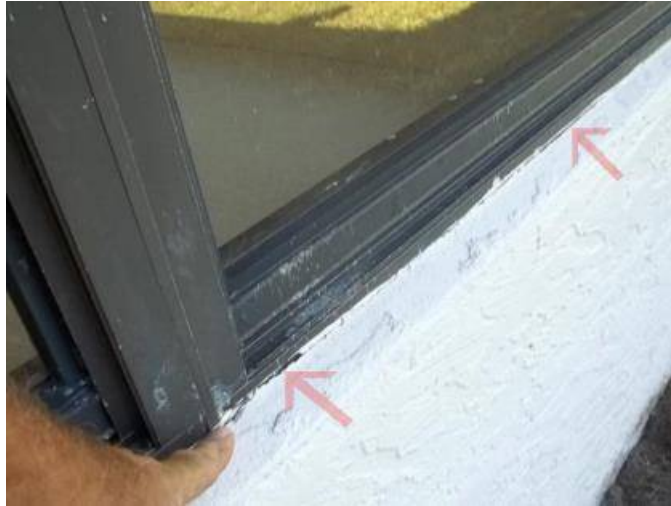
Enclosed patio: Improper or lack of flashing/sealing at the windows allows water/moisture into the building envelope and is conducive to water damage.

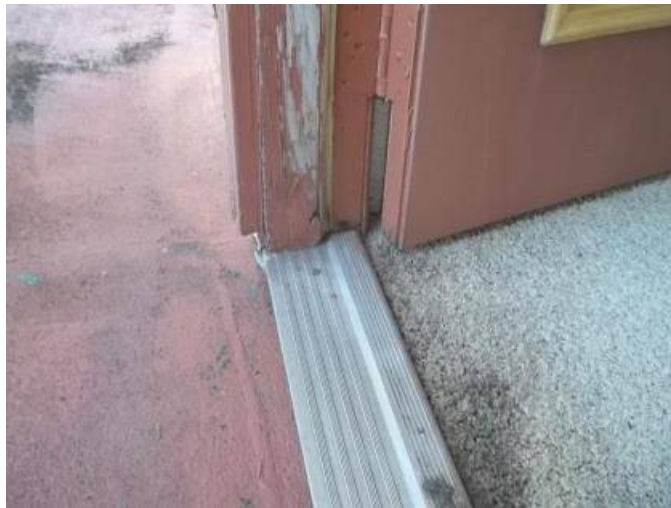
Enclosed patio: Water damage present to structural frame.

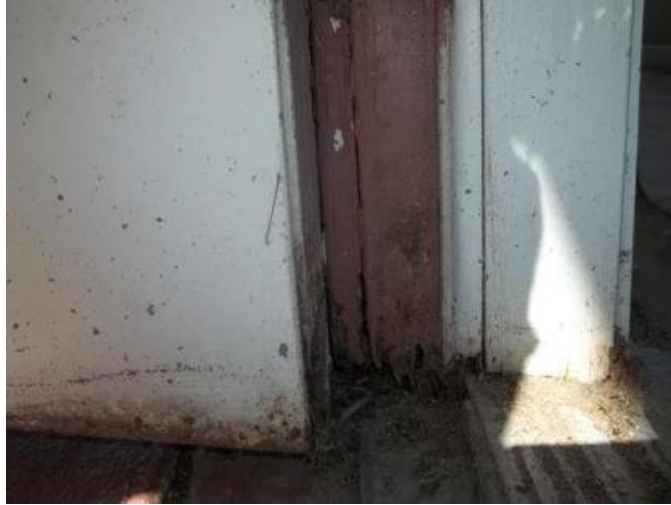
Pedestrian door: Water damage present to structural frame. Wood chord of the door is water damaged.

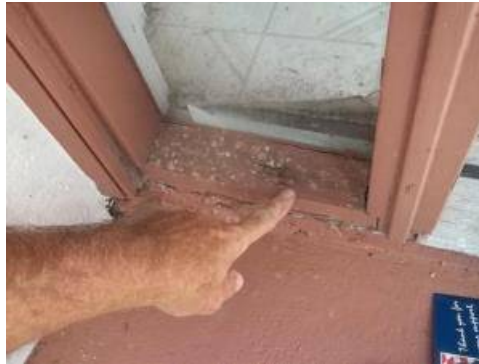
Front door has water damage at side light frame.

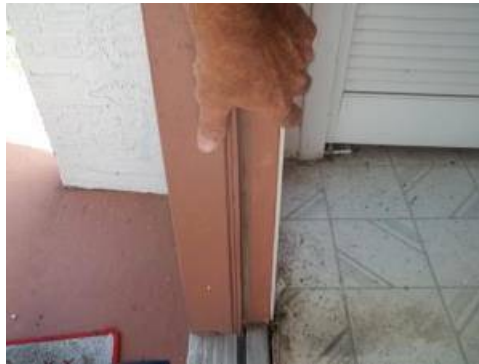
Front door: Structural door frame is loose in opening.

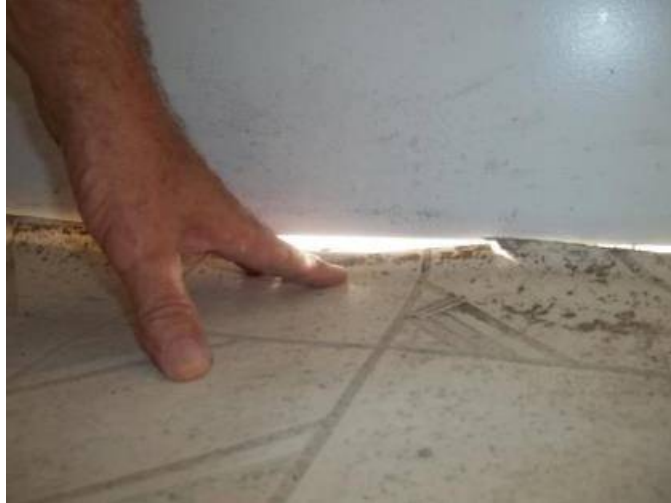
Front door: The weather-stripping is missing towards the bottom of the door at threshold leaving large open gap, not air or watertight.

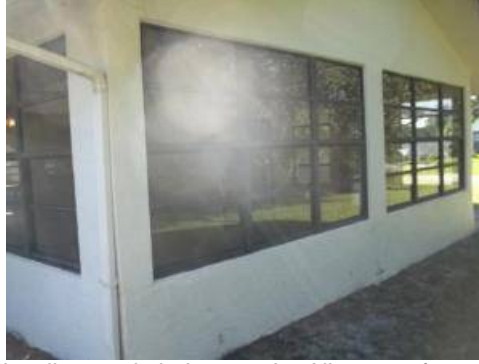
Enclosed patio: Stucco over wood framed wall extends below grade. All types of exterior finishes should not be any closer than four inches (4") above finished grade. Foundation is not exposed as it should be and no foundation screeds viewed.

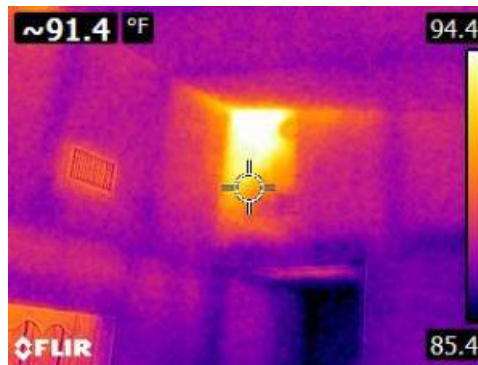
Batt insulation is missing off of some of the vertical walls in the attic space.

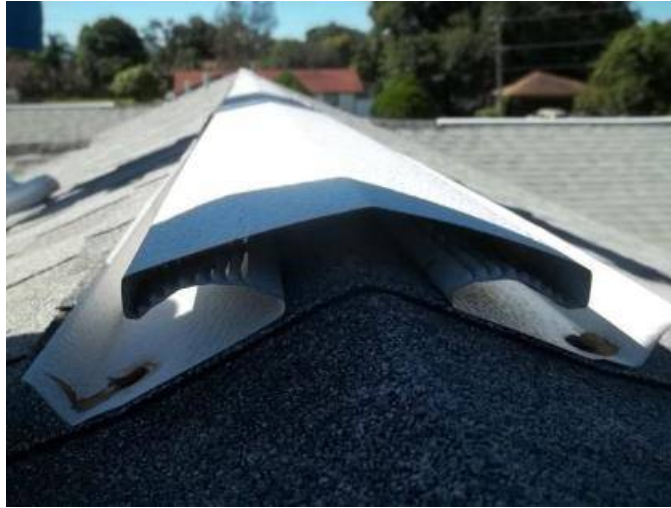
Rusted unsealed nails at ridge vents. The potential for water entry is present.

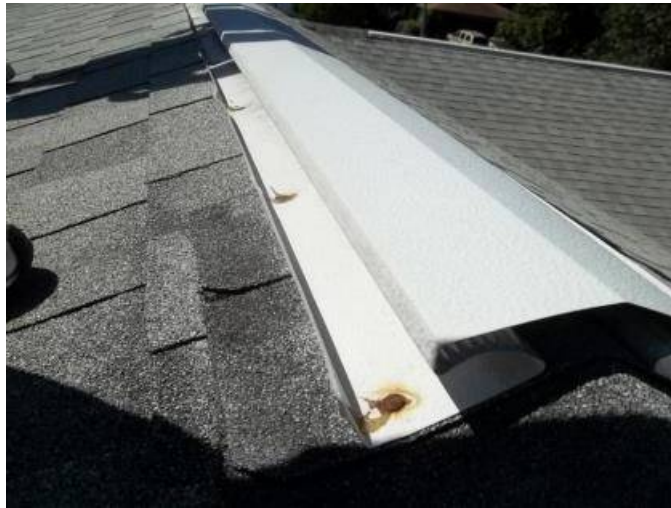
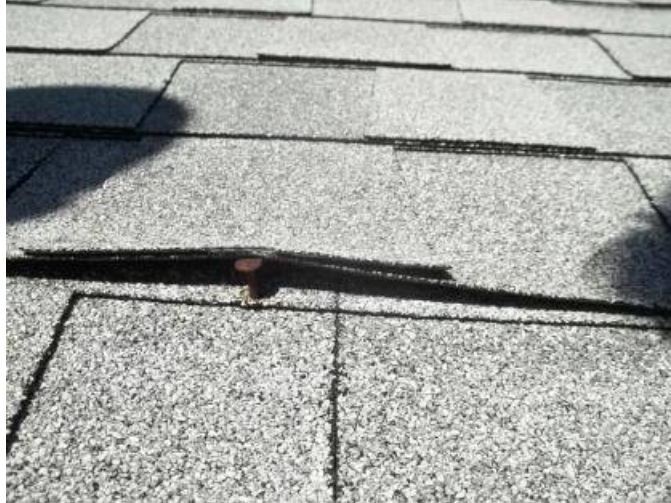
Nail pop (fish mouths) viewed. Nails pops are nails that have backed out, punching a hole in or raising the overlapping shingle. Others might exist. This can be caused by inadequate or improperly driven nails.

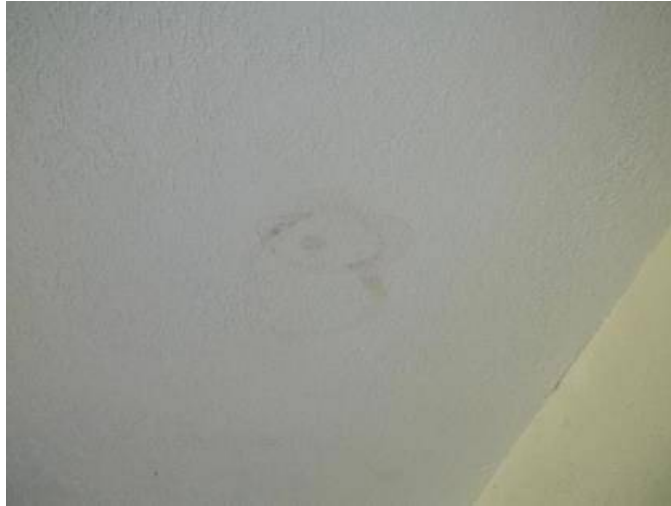
Observed water staining on ceilings in enclosed patio. Leakage from above could be at the unsealed rusted nails at the ridge vent.

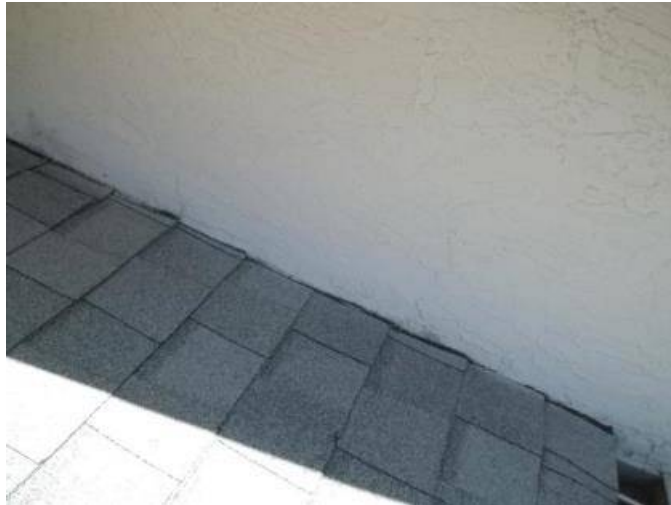
Stucco at shingle level at vertical sidewall junctions without the benefit of exposed flashing. This would provide better roof drainage and pull the metal lath and stucco up out of the water collecting at the flashing. The current installation is conducive to the metal lath rusting and then causing the stucco and lath to come apart and come loose from the wall.

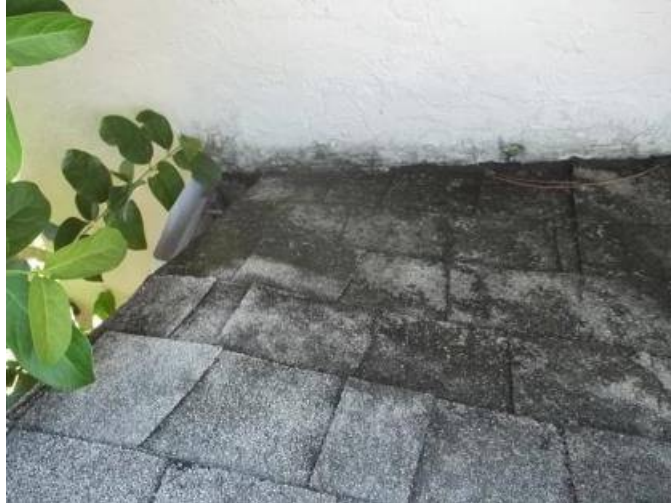
The kickout flashing is missing from the bottom of the roof to wall junctions. Water entering behind stucco in these areas.

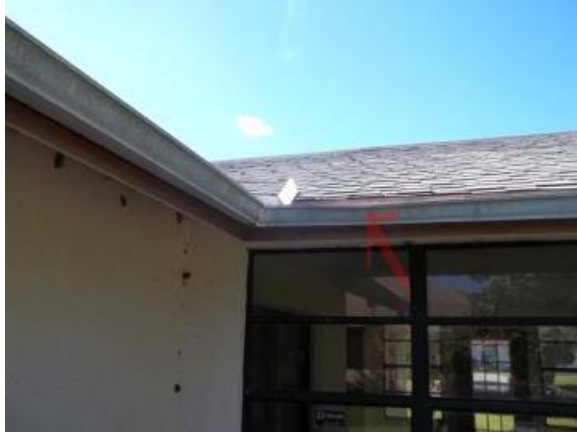
Enclosed patio: The gutter doesn't slope to drain properly.

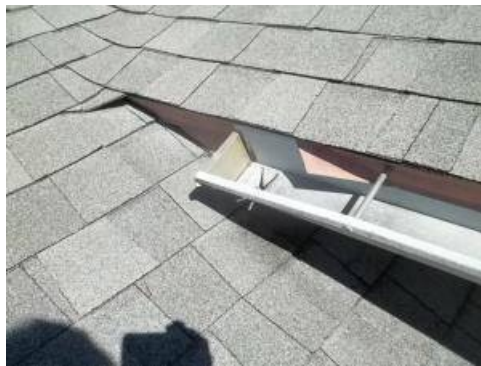
Observed gutters that terminate on lower roofs. It is apparent that the water being directed on the roof covering will cause that area to have localized shingle wear. I would recommend the water draining off of the upper portion of the roof be directed to the gutters attached to the lower roof edge so the water can be diverted off the roof surface properly as this is what the function of the gutter is.

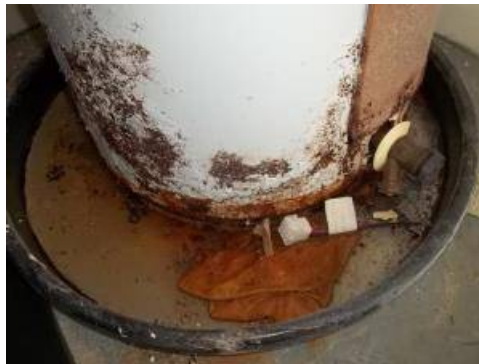
Water is off at the water heater, unable to check hot supplies throughout the house. Visible inspection only.

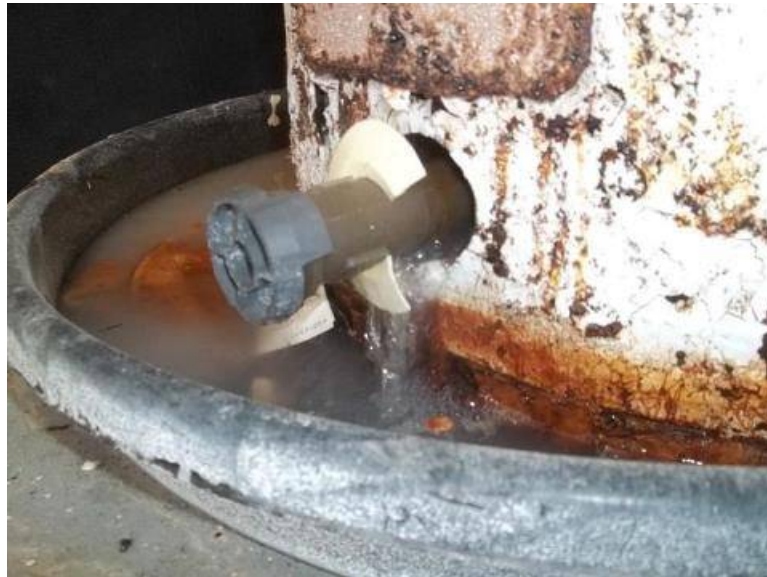
Leaking water out of the bottom of the water heater.

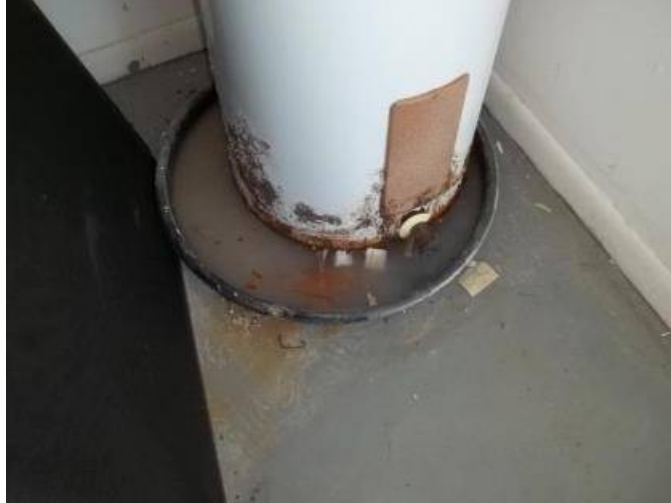
Water heater was installed in garage; The drain line exit is above the floor level of the home, water seeks its own level, drain line will not function as intended.

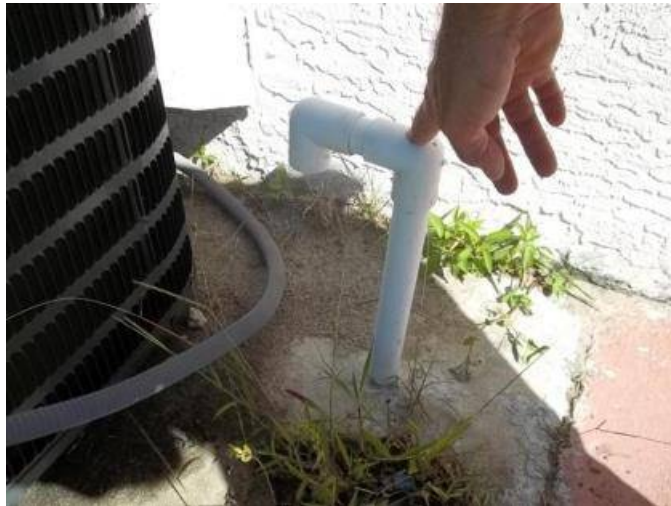
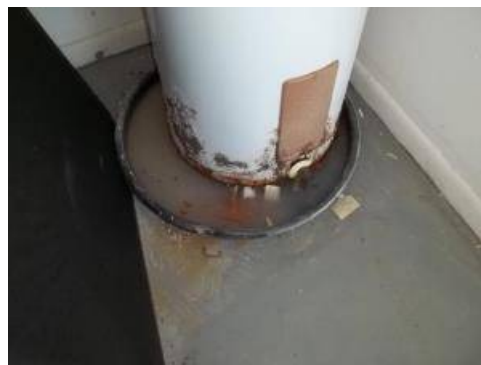
Bottom of heater is rusted out.

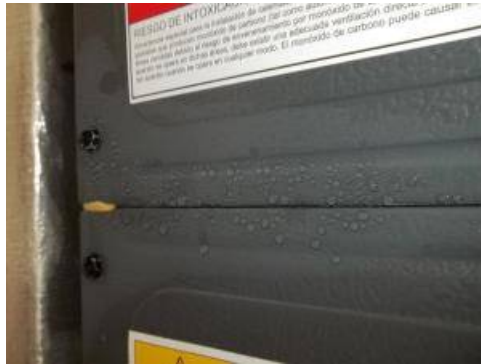
Air handler unit is not sealed in the garage. This air handler unit is located in a non-conditioned space which is susceptible to drawing contaminated non-conditioned air into the return air side and distributing it throughout the house. This includes fumes, gases, chemicals and carbon monoxide; All air handlers located in space they do not condition must be sealed from the surrounding air and environment.

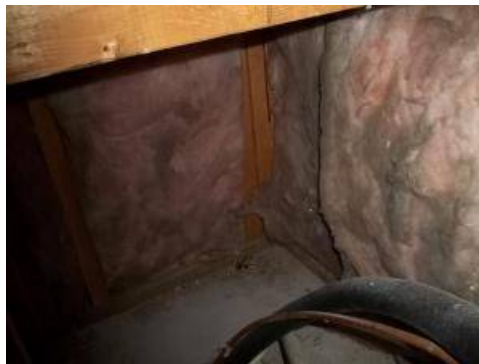
Air return area that is located under air handler is not sealed properly. This air handler unit is located in a non-conditioned space which is susceptible to drawing contaminated non-conditioned air into the return air side and distributing it throughout the house.

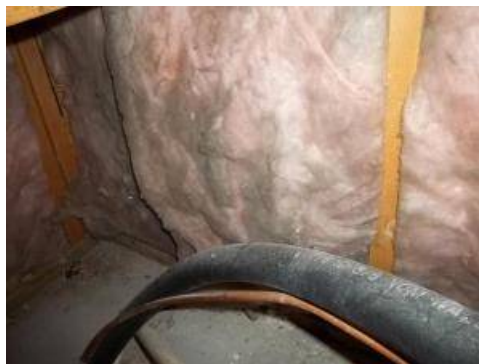
Fiberglass insulation exposed in return, this is not a cleanable material without disturbing fiberglass.

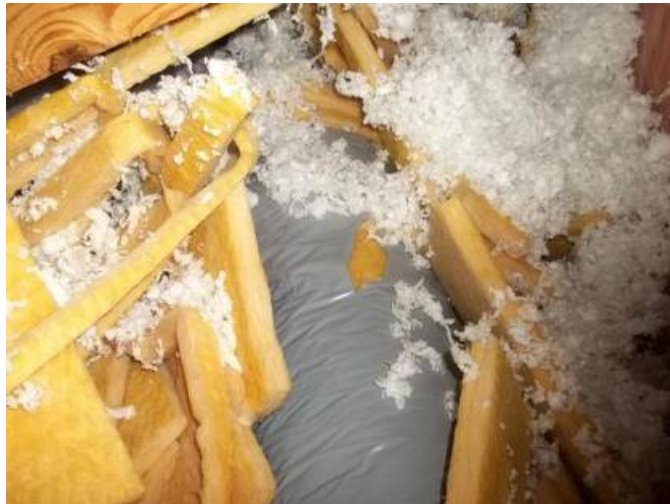
One area of a torn outer wrap. Grey plastic Allow Flex. In the late 1980's, manufacturers of insulated flexible duct discovered that the products with gray polyester jackets could fail when exposed to direct or indirect sunlight. The ultraviolet rays in the sunlight would break the chemical bonds in the gray polyester jackets causing them to disintegrate over a period of several years.

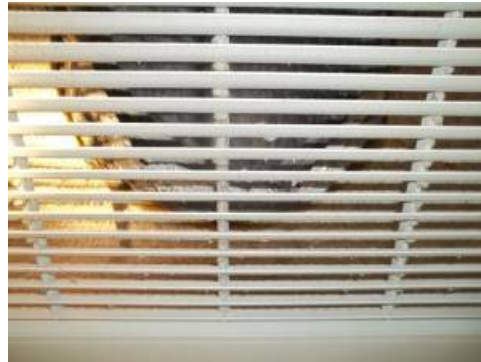
Loose duct connections inside of the return on the hallway ceiling.

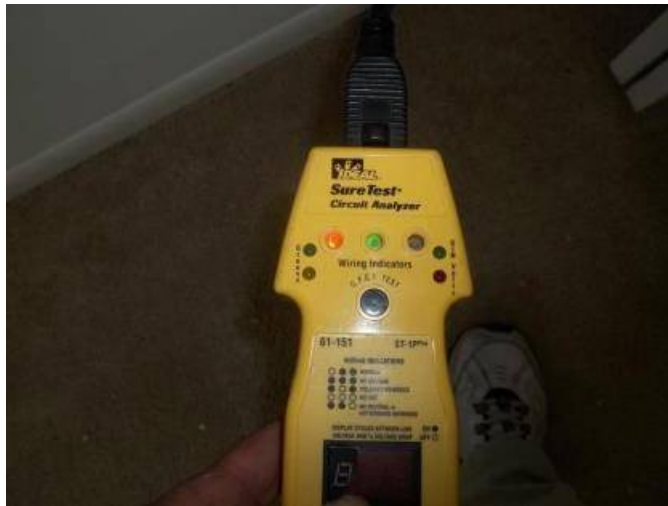
Outlets did not function properly in the left of the hall bedroom, the outlets are missing neutrals or have hot and grounds reversed.

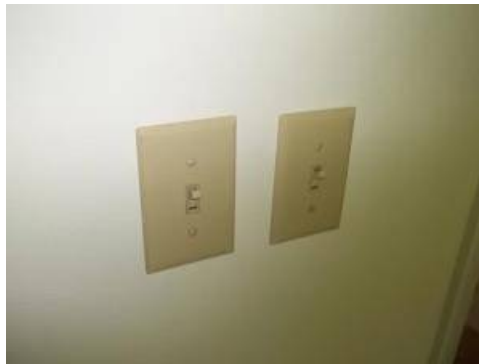
Switches are not operating properly in left of the hall bedroom.

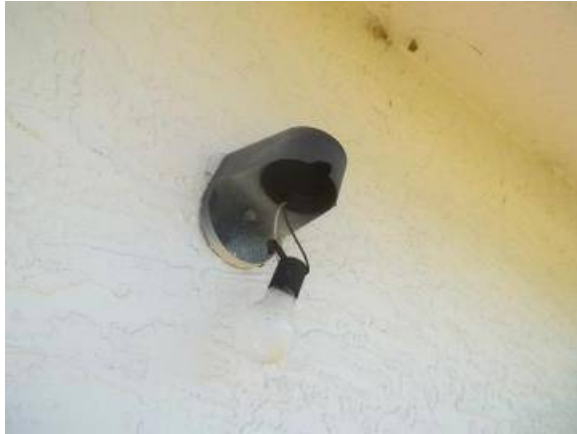
Exterior light fixture hanging from wires near the pedestrian door.

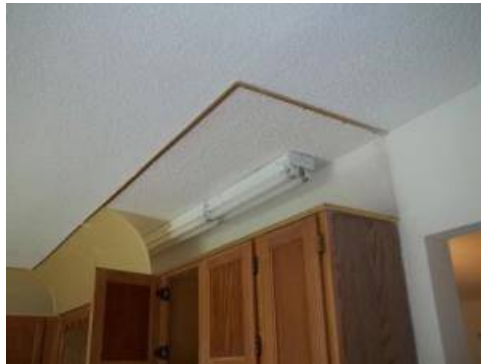
Light lens missing from light cove.

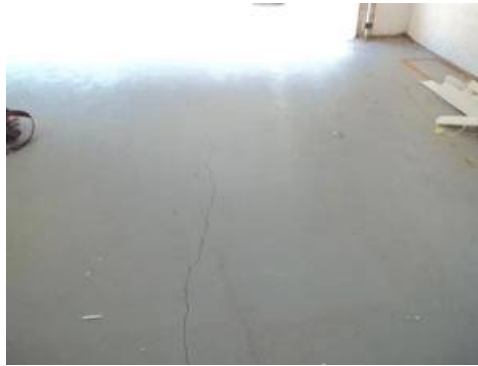
Cracks noted: No expansion joints present to help mitigate cracking.

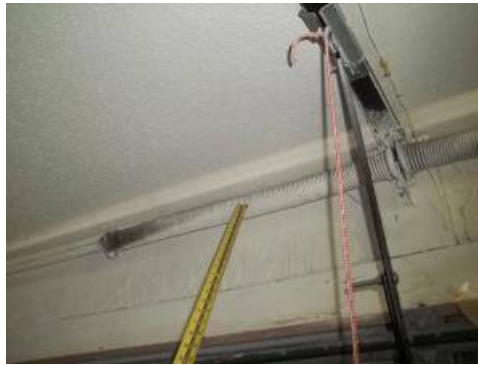
I checked the balance on the door with the emergency release handle disengaged. Door did not remain in the position it was left in. Door closed rapidly. An improperly balanced door could cause severe injury or death. Have a qualified service person make repairs to cables, spring assembly and other hardware.

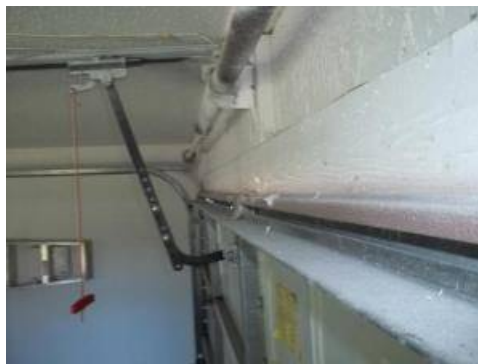
Bent top panel at overhead door.

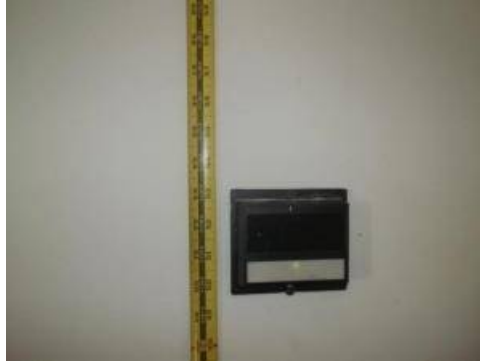
The controls are closer than 5 feet to the nearest standing surface and should not be, this is so a child can't reach them from either the floor of the garage or the floor of the room leading into the garage.

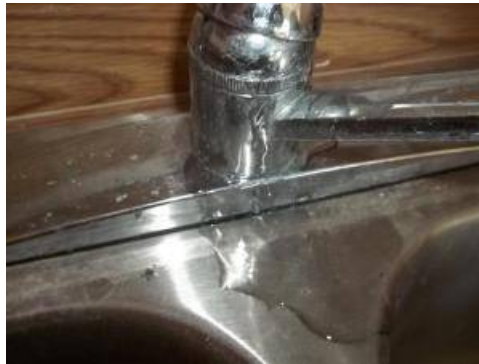
Faucet leaks at controls.

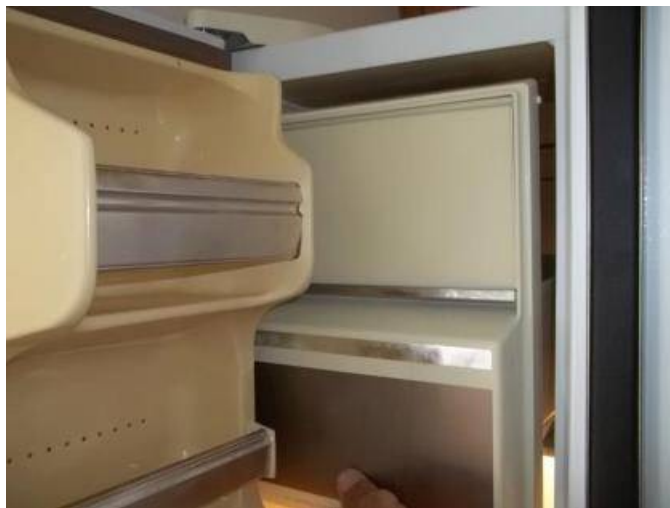
Refrigerator is oversized for opening provided restricted space.

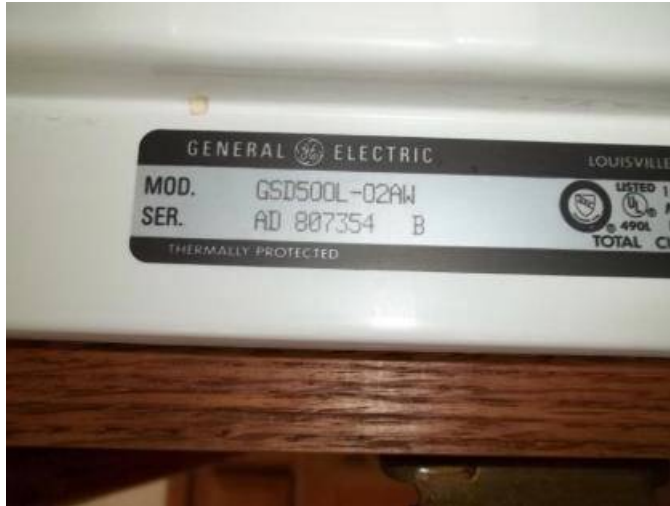
There has been a manufacturer's recall of some General Electric and Hot Point brand dishwashers. Some 3.1 million dishwashers manufactured between 1983 & 1989 have defective slide switches that can melt and ignite resulting in a fire hazard. The following model numbers are involved in the recall. GSD500D, GSD500G, GSD540, HDA467, HDA477 or HDA487 that have a serial number with a second letter of A,M,R,S,T,V,or Z.. Discontinue use immediately. Unlatch the door. Immediately contact GE at 1-800-599-2929 anytime, or contact them at [www.geappliancerecall.com](http://www.geappliancerecall.com).

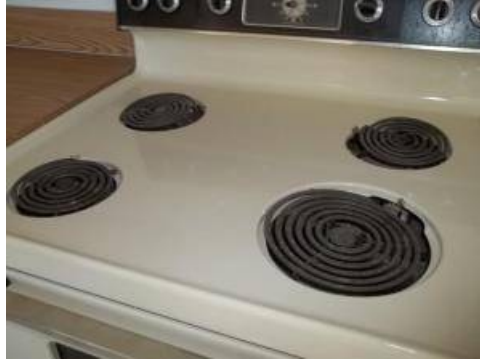
Cooktop missing burner drip pans.

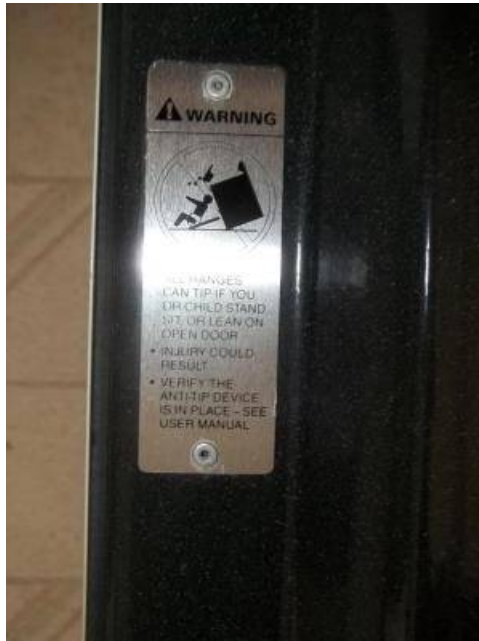
Did not view anti-tip bracket. This bracket is essential to the safe operation of the range. It provides protection when excess force or weight is applied to an open oven door. Anti-tip devices became a UL (Underwriters Laboratories) requirement June 3, 1991. See warning of door requiring anti-tip bracket be installed provided by manufacturer.

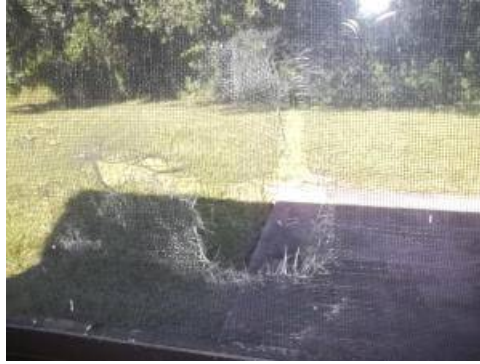
Bug screens damaged and missing several windows.

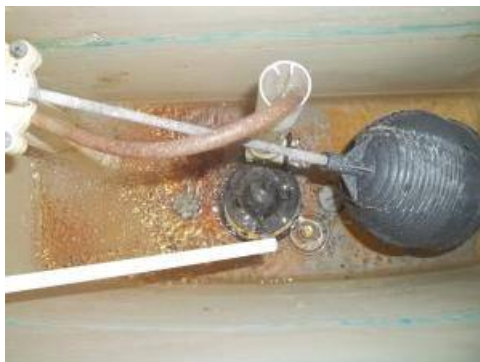
Flapper or flush valve is not seating properly on the valve seat, it needs replacement. This is typically the cause of running toilets. Over time, the valve's rubber material deteriorates because it is constantly under water.

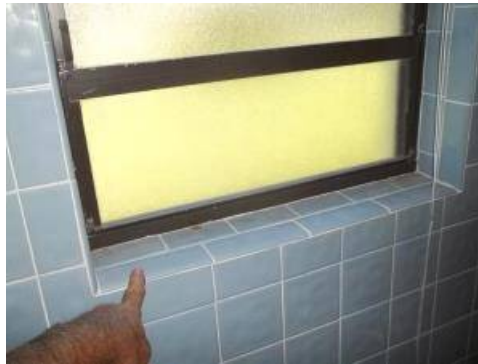
Tiled horizontal ledge, this is an area conducive to water entering into grout joints and then damaging wall behind. When replacing recommend solid surface sloped to divert water into shower area to drain.

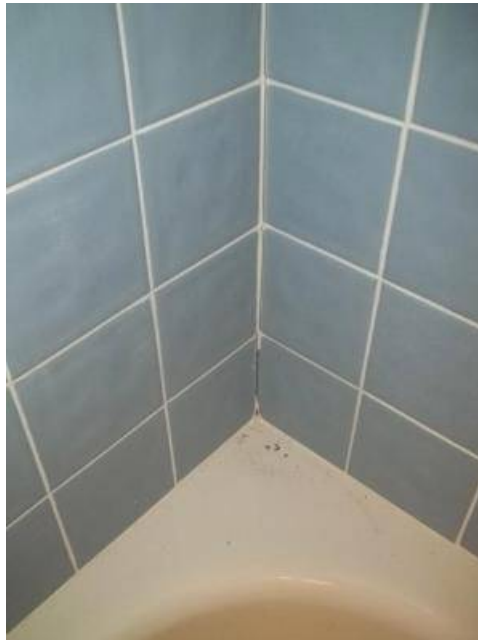
Missing grout in corners, open path for water to enter behind tile. Possible hidden damage to substrates from water entering.

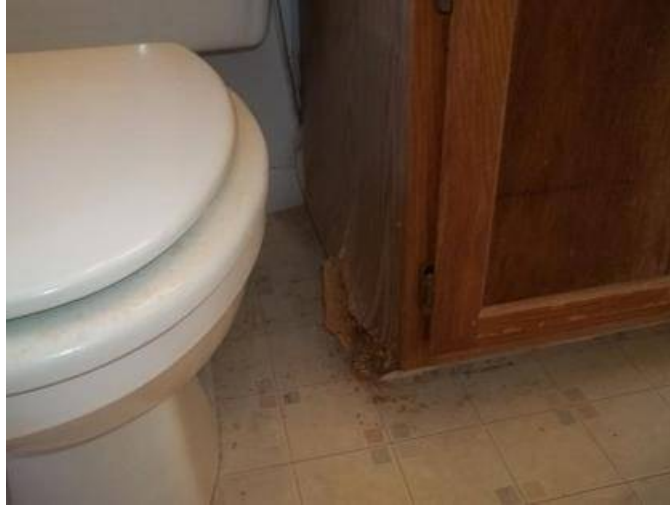
Water damage present to vanity. Possible hidden damage under and behind vanity. Result of ongoing leakage.

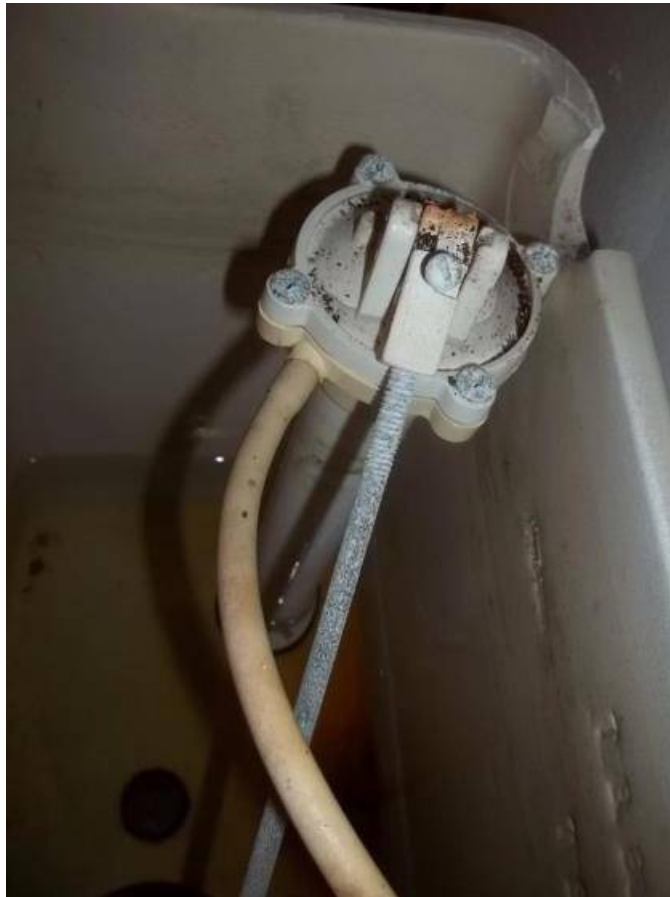
Fill valve not operating properly.

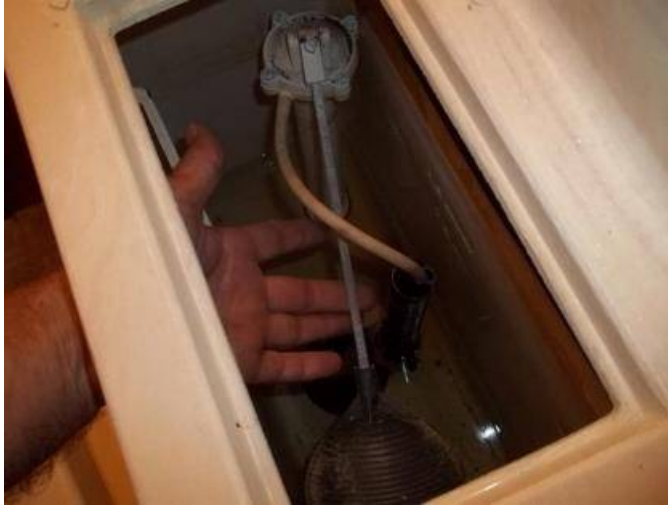
The float ball switch is broken.

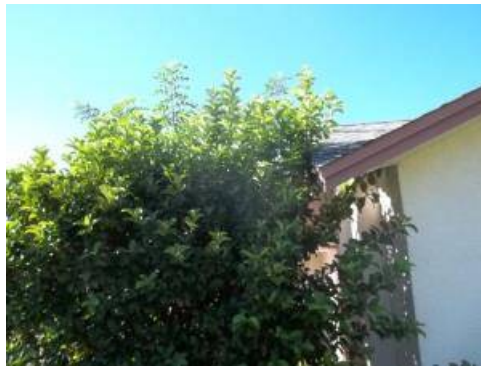
Trim plants away from structure.

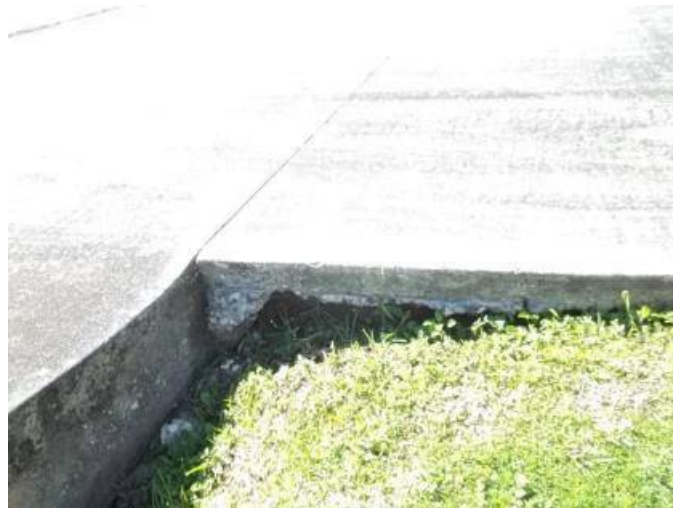
Driveway is undermined at culvert location.

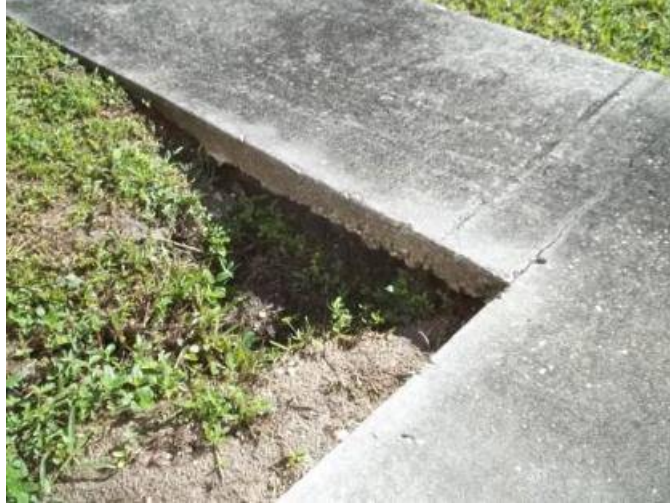
Uncontrolled rain water from the roof has caused undermining of the sidewalk.
