# **Confidential Inspection Report**

**Palm Bay, FL**

**September 14, 2014**

**Inspector: Ronald Burns HI939**

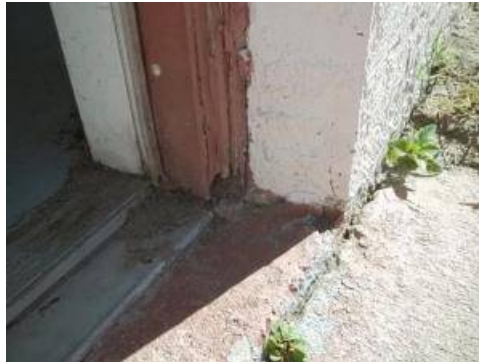
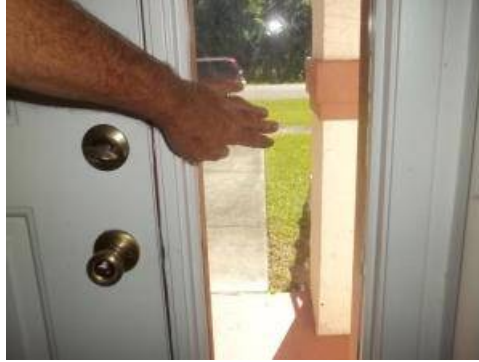
Front door has water damage at side light frame.

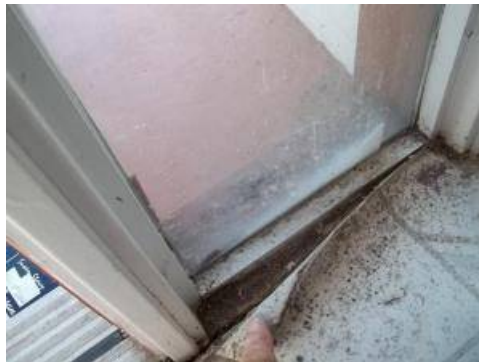
Front door: Structural door frame is loose in opening.

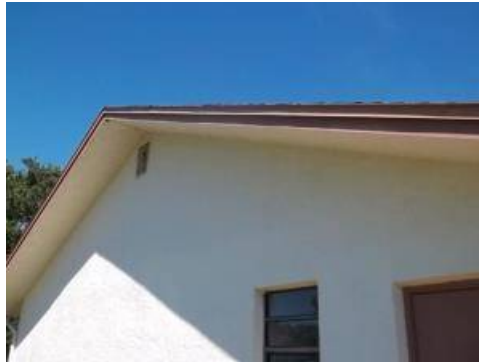
No control joints where gable ends which are wood framed abuts block walls below. Control joints should be placed at the juncture of different types of construction. Control joints are used to provide relief of stresses thus controlling cracking. Failure to allow free movement will result in cracking. Refer to ASTM standards C1063.

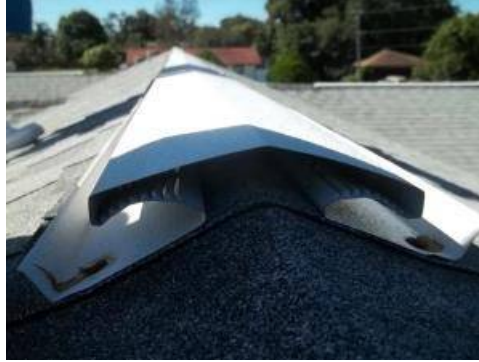
Gable vent south side: Open to attic space top side of vent where it is not sealed, conducive to rodent entry.

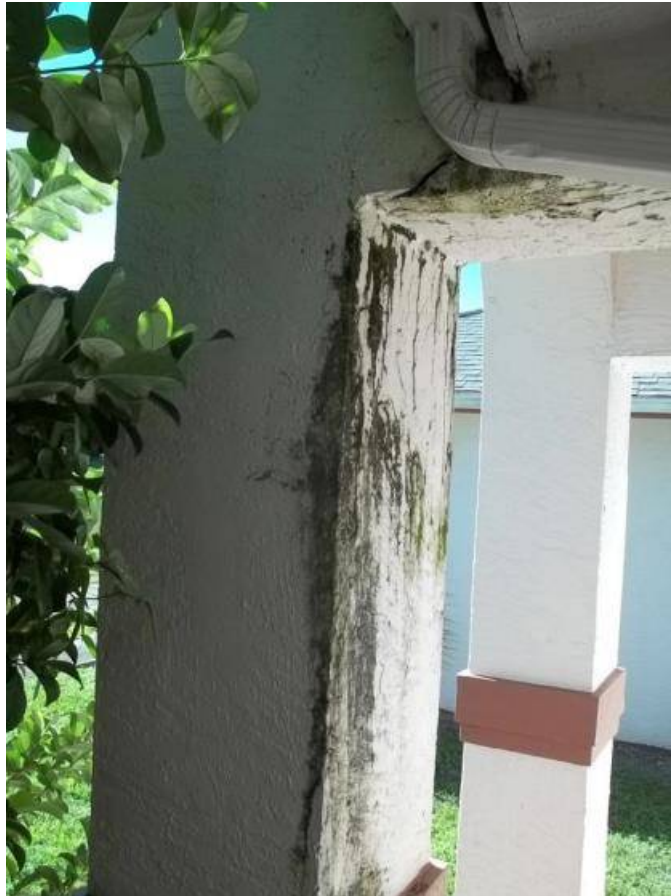
Evidence of active leakage: Water damage is visible on the header and at column adjacent to and above the front entry door, leakage is occurring at sidewall junctions. This can be contributed to improper installations of the flashing and/or roof covering in this area.

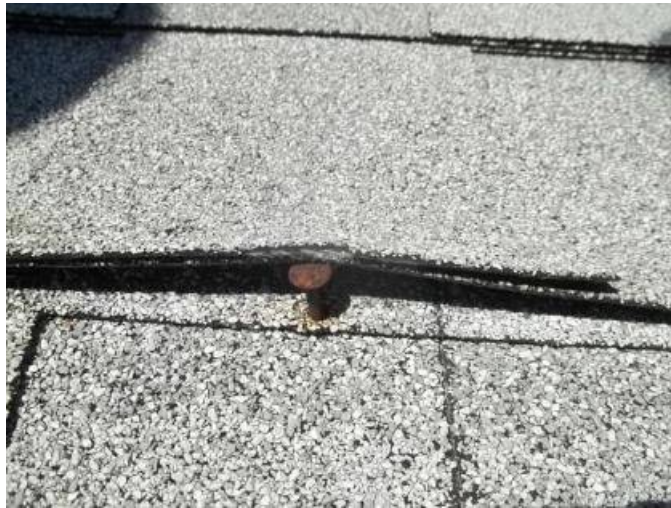
Nail pop (fish mouths) viewed. Nails pops are nails that have backed out, punching a hole in or raising the overlapping shingle. Others might exist. This can be caused by inadequate or improperly driven nails.

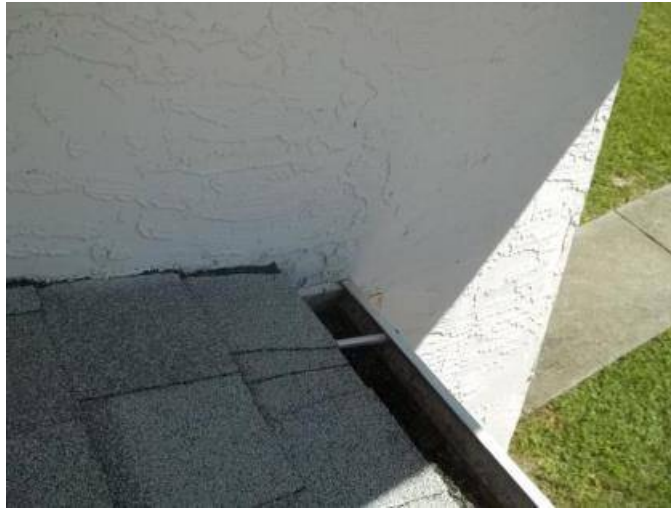
The kickout flashing is missing from the bottom of the roof to wall junctions. Water entering behind stucco in these areas.

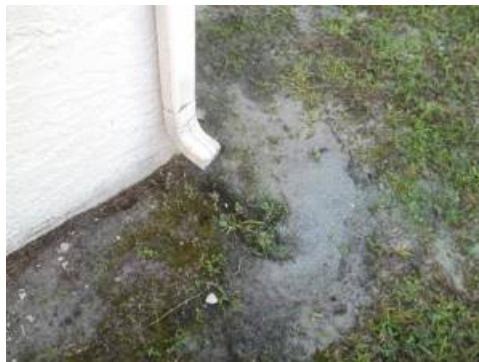
Extensions missing from terminations where downspouts are present. Roof downspouts should discharge at least 1 foot away from the structure sidewall, whether by underground piping, tail extensions, or splash blocks.

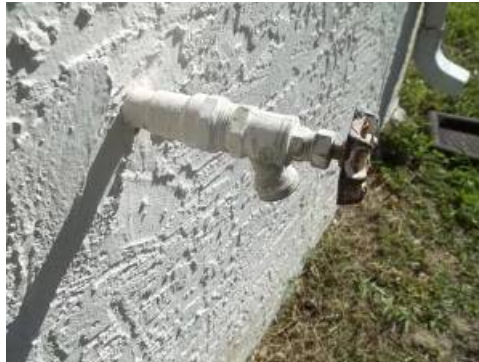
Hose Bib on the south side is missing a backflow preventer.

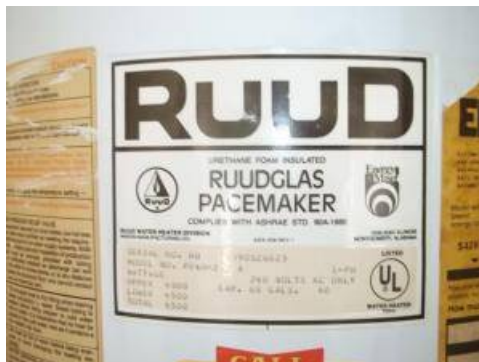
Based on the serial number, the water heater is estimated to be 24 years old. Average expected life is 8-10 years.

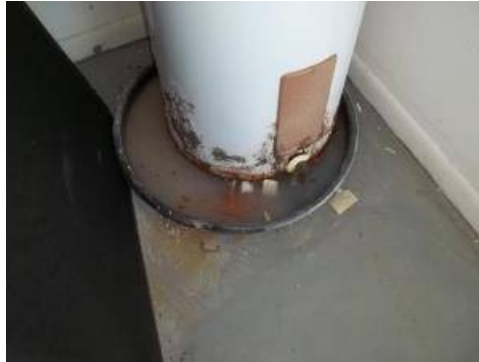
Leaking water out of the bottom of the water heater.

Bottom of heater is rusted out.

Warrants replacement, see comments below.

Warrants replacement, see comments below.

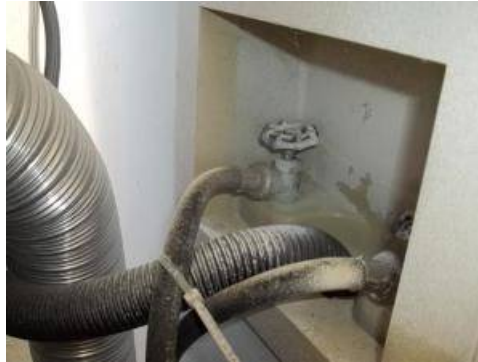
Washer hoses should be replaced.

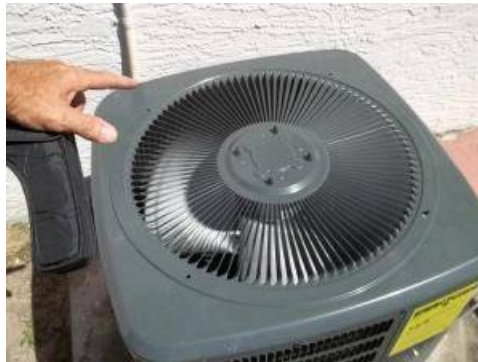
Heating system not operating properly, the condenser came on at the same time as the electric heat.

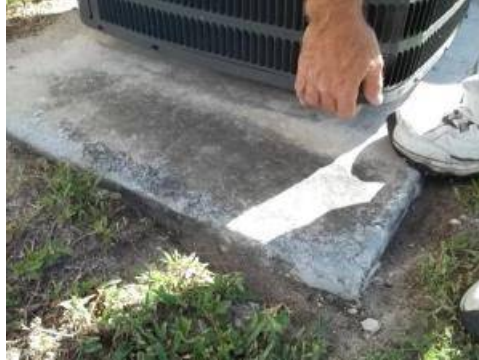
Condensing unit is not mounted to mounting pad, recommend doing so as have a stable secure base for unit as is an area that is subject to high winds.

Condensing unit is not mounted to mounting pad, recommend doing so as have a stable secure base for unit an is an area that is subject to high winds.

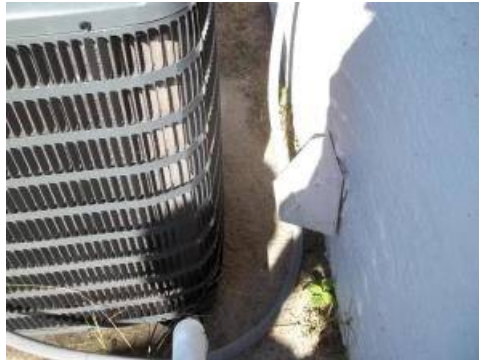
Dryer venting within 1 ft of unit, Dryer is venting behind the condensing unit, recommend relocating dryer vent to an appropriate location.

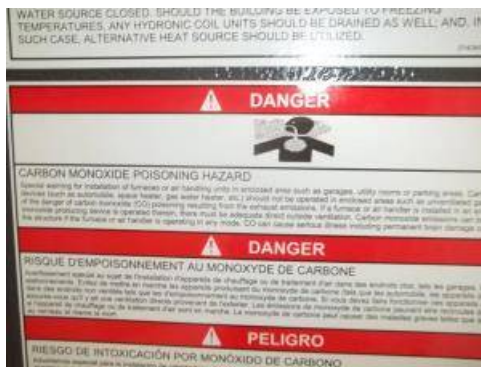
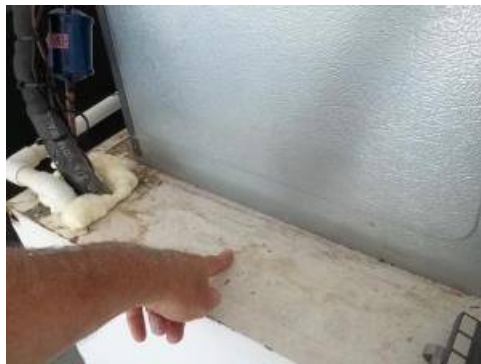
Air handler unit is not sealed in the garage. This air handler unit is located in a non-conditioned space which is susceptible to drawing contaminated non-conditioned air into the return air side and distributing it throughout the house. This includes fumes, gases, chemicals and carbon monoxide; All air handlers located in space they do not condition must be sealed from the surrounding air and environment.

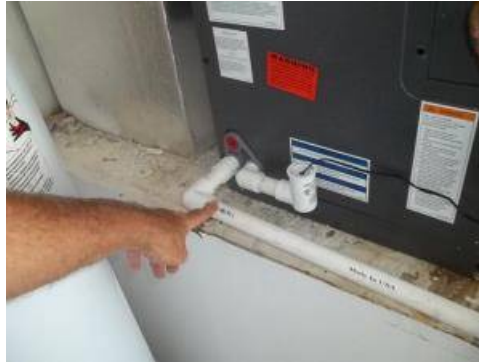
Piping Insulation. The condensation line is not insulated. All horizontal primary condensate drains within unconditioned areas shall be insulated to prevent condensation from forming on the exterior of the drain pipe.

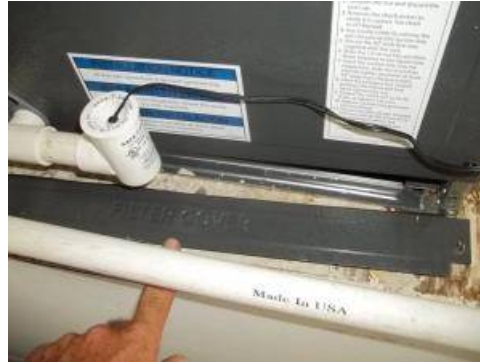
No filter at the filter compartment.

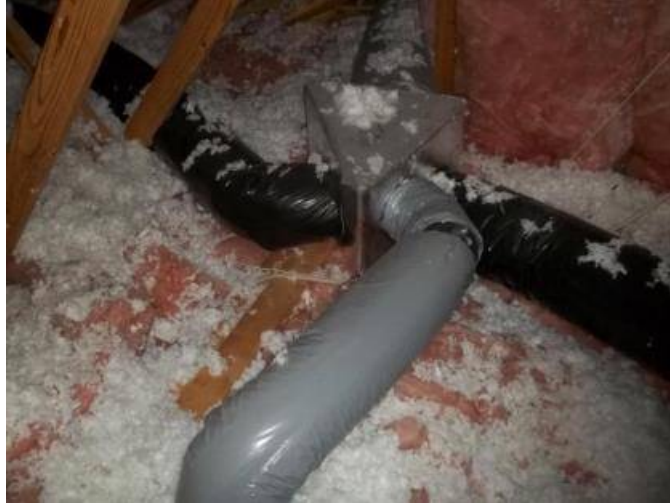
discovered that the products with gray polyester jackets could fail when exposed to direct or indirect sunlight. The ultraviolet rays in the sunlight would break the chemical bonds in the gray polyester jackets causing them to disintegrate over a period of several years.

One area of a torn outer wrap. Grey plastic Allow Flex. In the late 1980's, manufacturers of insulated flexible duct discovered that the products with gray polyester jackets could fail when exposed to direct or indirect sunlight. The ultraviolet rays in the sunlight would break the chemical bonds in the gray polyester jackets causing them to disintegrate over a period of several years.

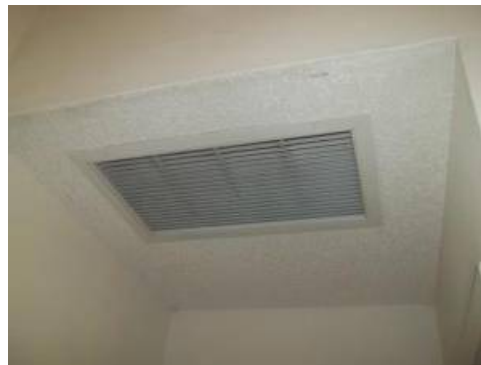
Loose duct connections inside of the return on the hallway ceiling.

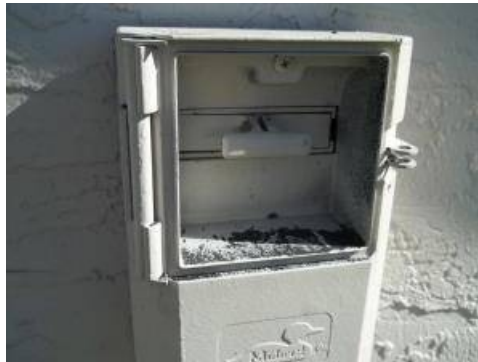
Condenser unit: Missing factory protective cover that was broken off of the electrical box.

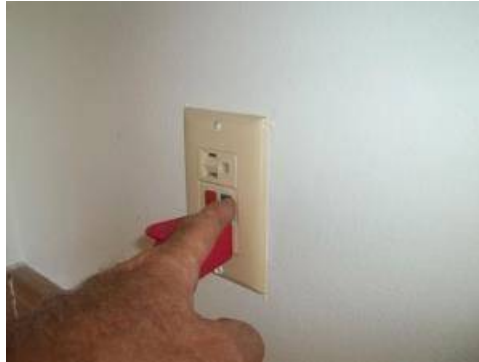
Ground fault circuit interrupter protection that was installed in kitchen is not responding to test button.

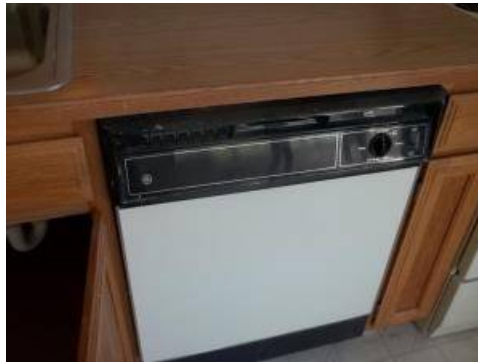
There has been a manufacturer's recall of some General Electric and Hot Point brand dishwashers. Some 3.1 million dishwashers manufactured between 1983 & 1989 have defective slide switches that can melt and ignite resulting in a fire hazard. The following model numbers are involved in the recall. GSD500D, GSD500G, GSD540, HDA467, HDA477 or HDA487 that have a serial number with a second letter of A,M,R,S,T,V,or Z.. Discontinue use immediately. Unlatch the door. Immediately contact GE at 1-800-599-2929 anytime, or contact them at [www.geappliancerecall.com](http://www.geappliancerecall.com).

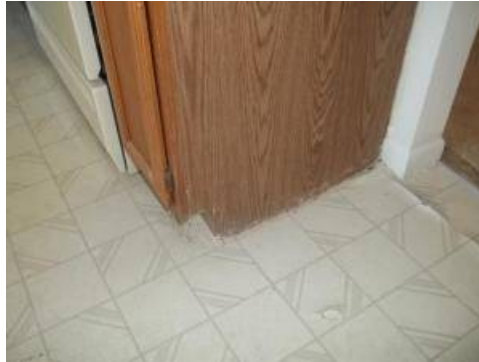
Some water damage to the side of the cabinet next to range.

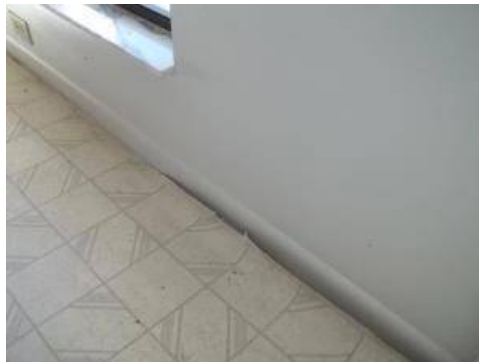
Damaged loose vinly floor covering throughout.

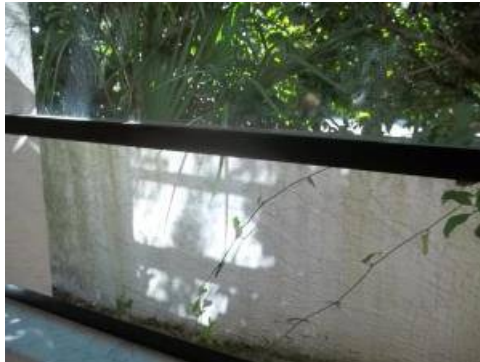
Bug screens damaged and missing several windows.

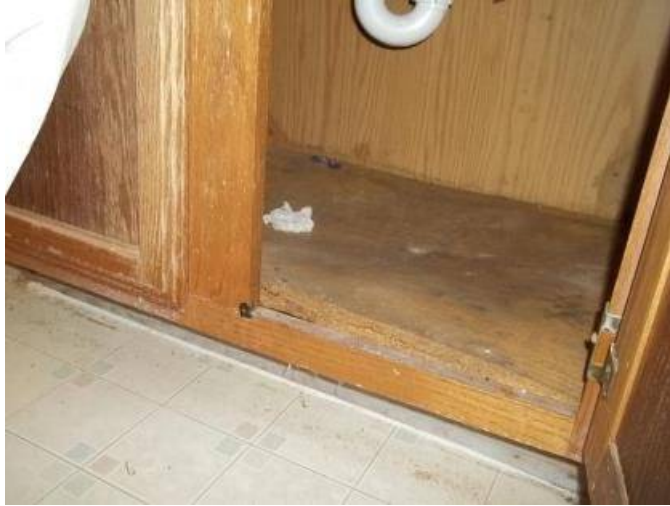
Water damage present to vanity. Possible hidden damage under and behind vanity. Result of ongoing leakage.

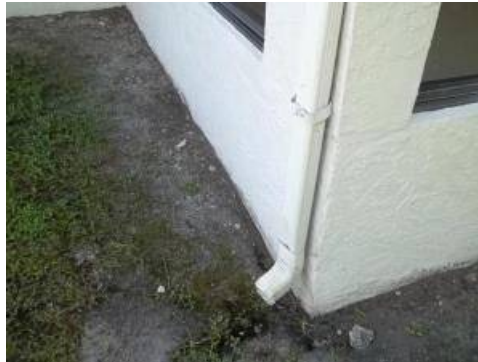
Uncontrolled rain water from the roof has caused erosions at the home's foundation.
